Health Consultation

Master Park Site
Near Intersection of South 160 Street and
International Boulevard
SeaTac, King County, Washington

January 6, 2006

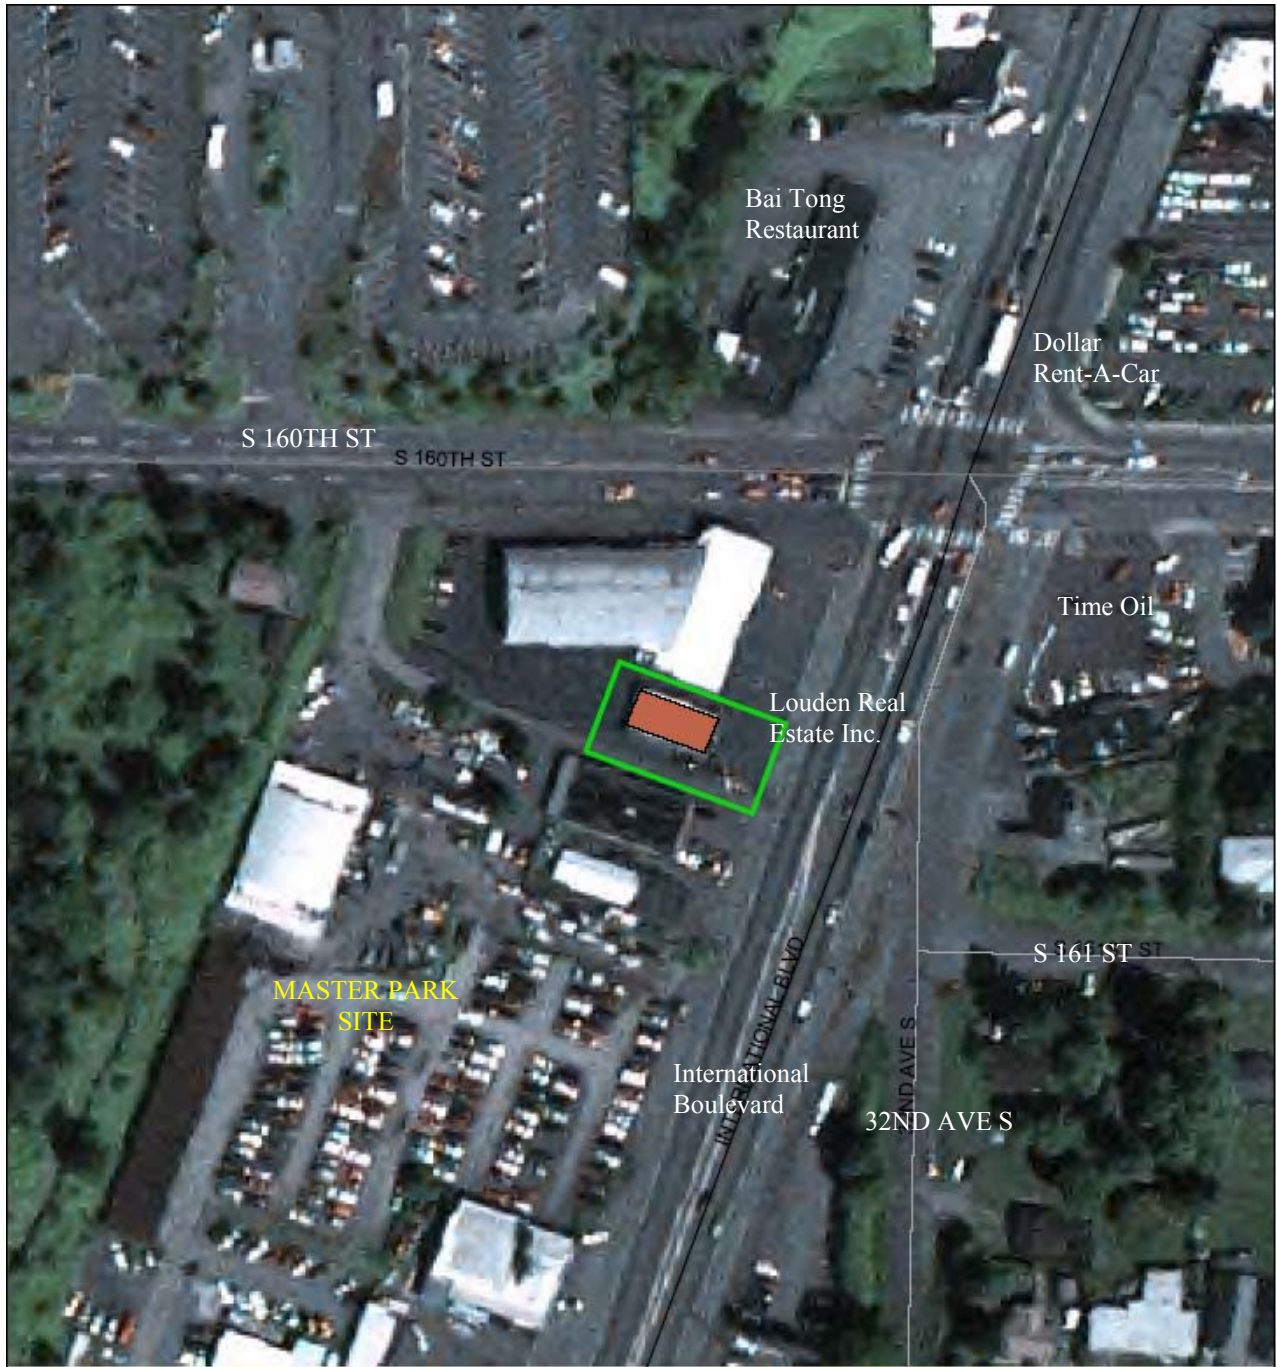
**Figure 1 – Vicinity Map
Master Park Site
SeaTac, Washington**

Currently the Master Park site consists of a parking lot with a small building (Figure 1). Historically this site was occupied by various commercial facilities that used or handled petroleum products, chlorinated and non-chlorinated solvents, as well as other chemicals (e.g., styrene) including, but not limited to:
