**Skagit County/Environmental Canine Services
Human Sewage Detection Project**

**Skagit County Public Works
Environmental Canine Services**

June, 2014

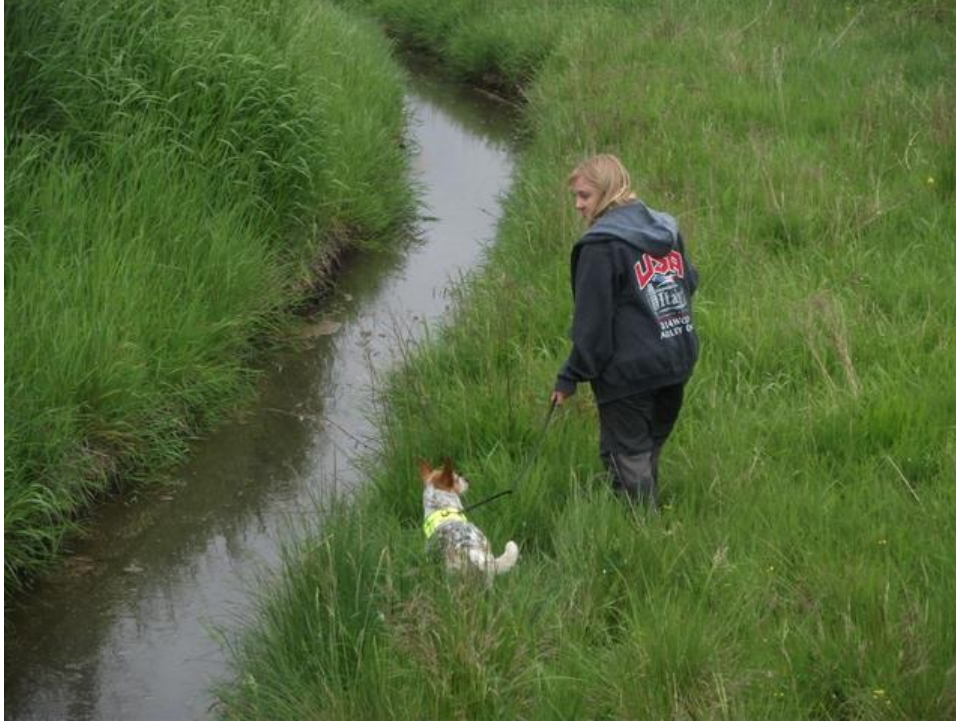
Figure 1. Crush and Aryn check out a ditch in the Samish Basin

This project used two methods of exposing the dog to samples: The “Bucket Test” method, where field samples were brought into a scent-neutral parking lot and placed in open containers for the dog to smell; and field tests, where the dog was taken out to locations within the Samish Basin to check the waters in situ or in open containers near the source. Crush identified samples with human sewage by lying down next to the open container or watercourse. See Figures 1 and 2.

Field operations consisted of taking the dog to locations identified either by previous bucket tests or by high fecal coliform counts in areas suspected of having failing septic systems. At the identified locations, after ensuring traffic safety, the handler took the dog out of a vehicle and exposed it either directly to the watercourse in question or to a fresh sample in an open container in the cases where site

characteristics prevented direct access by the dog. The signal from the dog was the same as for the bucket tests. A distilled water field blank was tested in an open container in at least one location. On some occasions the dog bypassed an open container and proceeded directly to the watercourse with a positive reaction.

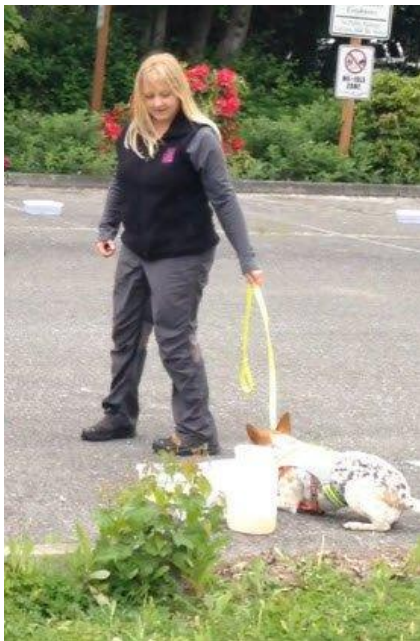
Figure 2. Crush detects human sewage in a bucket sample

For the bucket tests, open containers (approx. 4-L) were distributed through the parking lot with about 5-m of spacing to prevent cross-contamination of odors. Samples were processed in groups of 12. Samples were carefully poured into the containers with an identifying tag visible. Once all the samples were distributed, the handler led the dog to the containers one by one. If the dog detected human sewage in a sample, she sat next to it and was rewarded with a small treat by the handler. Then the dog would go on to the next sample until all 12 samples in the set had been examined. The dog worked quickly and examining the whole sample set would take about one minute. Dog reactions were recorded by County staff with assistance from the ECS Manager. Once the sample set was processed, the samples were capped and removed approximately 100 m away to prevent carryover odors.

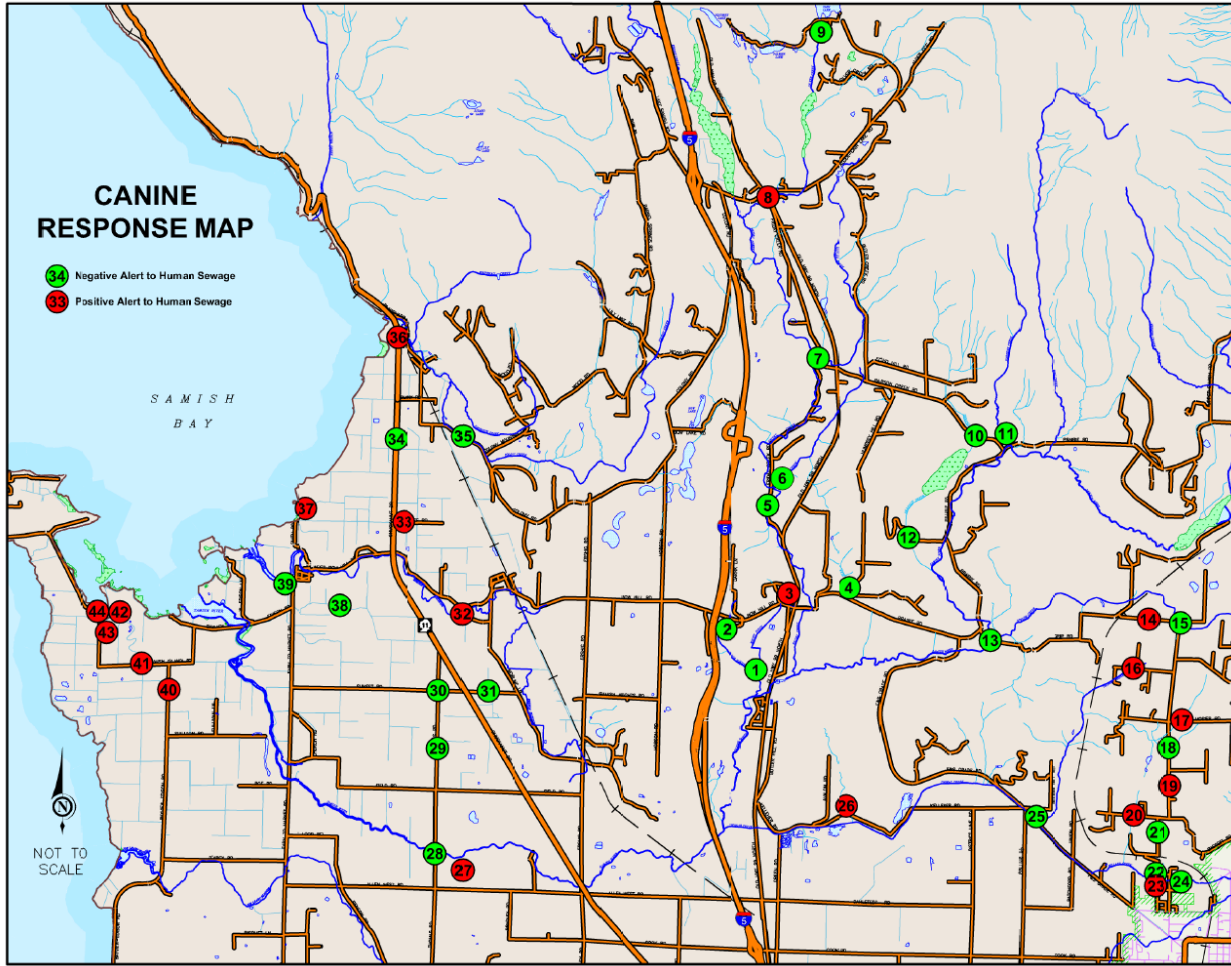
Figure 3. Map of positive and negative canine response locations (see site key on next page)

Site codes for Canine Response Map (Figure 3, above)

<u>Number</u>	<u>Site/Label</u>	<u>Description</u>	<u>Canine Response</u>
1	BSCreek	Bob Smith Creek near mouth	Negative
2	BSDark	WF Bob Smith Creek near Bow Hill Rd	Negative
3	BSUp	EF Bob Smith Creek at Bow Hill Rd	Positive
4	WCPR	Weir Creek at Prairie Rd	Negative
5	FC1	Friday Creek at first Friday Creek Rd crossing	Negative
6	WILDES	Wildes Creek at Friday Creek Rd	Negative
7	BCFCR	Butler Creek at Friday Creek Rd	Negative
8	SILVER2	Silver Creek at Alger Community Hall	Positive
9	CAIN	Cain Lake outlet	Negative
10	SKARPCR	Skarrup Creek at Parsons Creek Rd	Negative
11	PAR	Parsons Creek at mouth	Negative
12	SKAR	Skarrup Creek at Double Creek Ln	Negative
13	CAO8	Swede Creek a lower Grip Rd	Negative
14	White Pipe	Grip Rd, east of Hoogdal Branch Rd	Positive
15	SCGrip1	Swede Creek at upper Grip Rd	Negative
16	THOBridge	Thomas Creek at Bridgewater Rd	Positive
17	THOMOS	Thomas Creek (NE fork) at Mosier Rd	Positive
18	SFTHO	South Fork Thomas Creek at Grip Rd	Negative

19	Grip Rd/Greenough Ln	Ditch	Positive
20	22551 Cully Rd	Willard Creek tributary	Positive
21	8106 Garden of Eden Rd	At catch basin	Negative
22	Garden of Eden Rd/Kiens Ln	Willard Creek tributary	Negative
23	Garden of Eden Rd/Kiens Ln	Willard Creek west	Positive
24	Birch Ln	Willard Creek east	Negative
25	CAO4	Thomas Creek at F&S Grade Rd	Negative
26	BCCR	Butler Camp Creek at Kelleher Rd	Positive
27	VOSPIPE	Vos drain pipe at Samish River	Positive
28	CAO32	Samish River at Thomas Road	Negative
29	Wallace Farm	Thomas Road, between Sunset and Field Rd	Negative
30	Sunset & Thomas	Ditch at intersection	Negative
31	Sunset Ditch	east of Chuckanut Dr	Negative
32	ESBCR	Edison Slough at Bow Cemetery Rd	Positive
33	NE7	Estes Road ditch	Positive
34	4492 Chuckanut Dr	south of Colony Rd	Negative
35	CAO39	Colony Creek at Colony Rd	Negative
36	MCEGATE	Ditch draining to McElroy Slough	Positive
37	CAO38	North Edison pump station	Positive

38	Edditch	Ditch near Edison septic system	Negative
39	CAO37	Edison pump station	Negative
40	Alice Bay drainage	at Bay View-Edison Rd	Positive
41	Alice Bay drainage	at Samish Island Rd	Positive
42	CAO33	Alice Bay pump station	Positive
43	Alice Bay pump station road	left side	Positive
44	Alice Bay pump station road	right side	Positive

Field samples were taken mostly at previously identified locations although a few “samples of opportunity” were obtained. Samples were taken directly into new, pre-labeled 4-L HDPE sample bottles, rinsed three times with the water to be sampled. GPS coordinates were recorded at each sample site. A map of bucket sample sites and field tests is included as Figure 3.

Results from the bucket and field tests are listed in Tables 1 and 2. Positive and negative results are mapped in Figure 3.
